## **BBN Technical Memorandum No. 1270**

### **ANIMIDA Phase I: Ambient and Industrial Noise Measurements Near the Northstar and Liberty Sites During April 2000**

**Arctic Nearshore Impact Monitoring in the Development Area  
(ANIMIDA)**

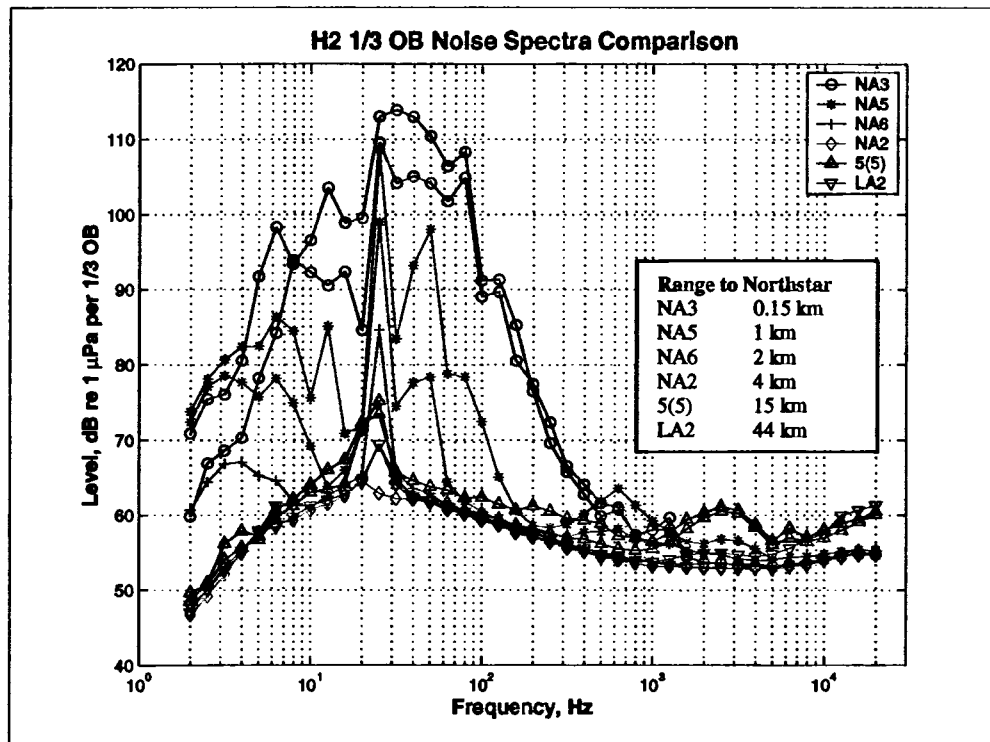
Figure 4.1-3 shows the measured 1/3 OB noise spectra for the mid-water column depth hydrophone (H2) collected at the same sites and times as shown in the previous figure with the vibrohammer in operation. As with H1, close to Northstar the underwater noise field is dominated by radiation from the island below 500 Hz, again rising as much as 45 dB above quiet background noise levels. One kilometer (.54 nm) from Northstar, man-made noise dominates only in the spectral region below about 100 Hz. And at a range of 1.1 nm (2 km) (NA6), again only energy in the 23 Hz tonal and at very low frequencies below about 7 Hz is detectable above normal ambient conditions. Unlike the 1/3 OB data from H1, both sites 5(5) and LA2 have a spectral peak near 23 Hz. While it is possible this energy is due to vibrohammer operation, it is unlikely because of the long range and the fact that H1 did not have the same characteristic. The cause, therefore, is unknown.

Figure 4.1- 3. Comparison of 1/3 OB spectra at multiple sites collected during vibrohammer operation using the hydrophone positioned in the middle of the water column (H2).

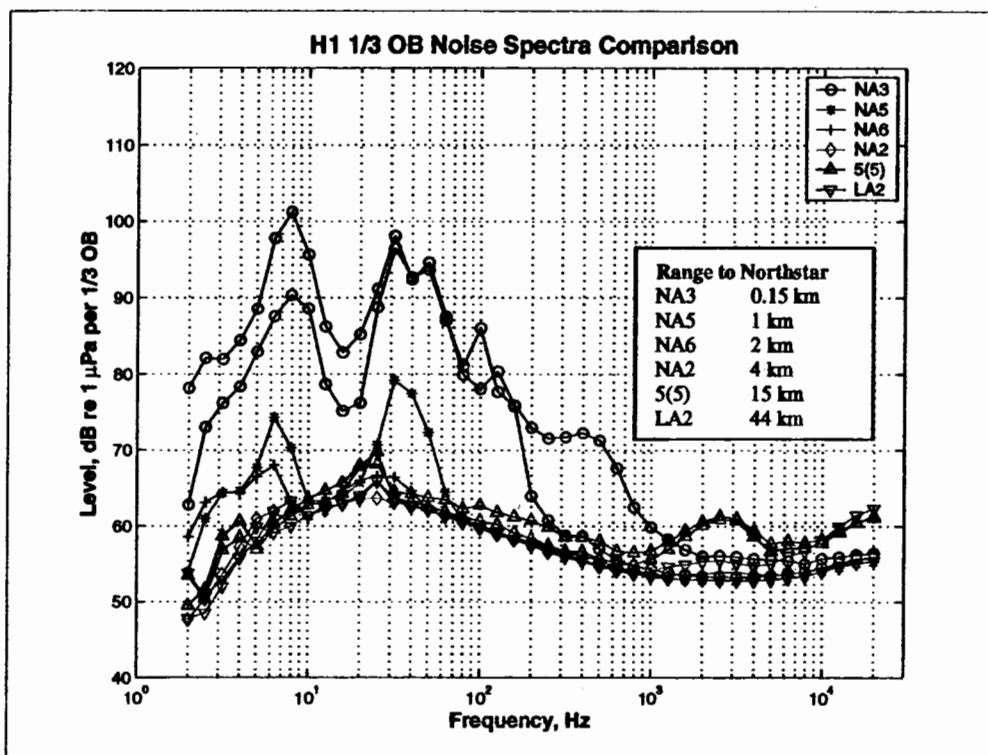
Figures 4.1-4 and 4.1-5 present comparisons of measured 1/3 OB spectral levels at the same sites when the vibrohammer was not in operation for H1 and H2, respectively. In both instances, the underwater sound energy at NA3 is dominated by island noise particularly in the band centered around about 8 Hz and in the band from 20 to 200 Hz. In general, the levels are roughly comparable with the near-bottom sensor receiving

slightly higher levels. At ranges beyond 1.1 nm (2 km), the man-made noise contribution to the ambient noise conditions is low to negligible across the measurement band.

Figure 4.1- 4. Comparison of 1/3 OB noise spectra at multiple sites without vibrahammer noise collected using the Hydrophone positioned near the bottom (H1).

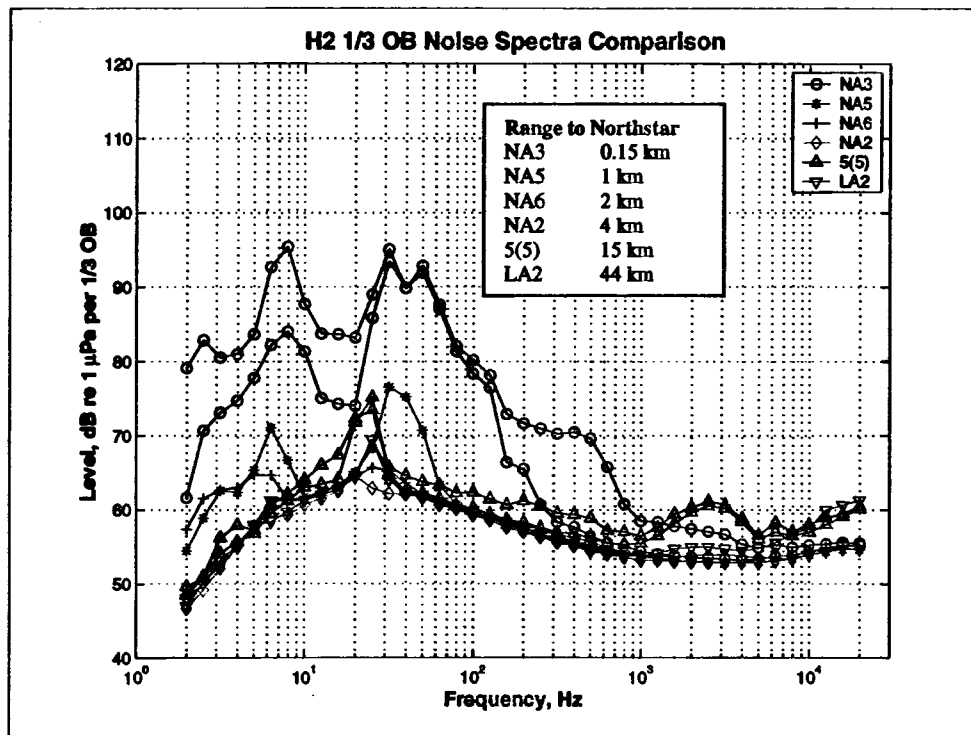
**Figure 4.1- 5. Comparison of 1/3 OB noise spectra at multiple sites without vibrohammer noise collected using the Hydrophone positioned in the middle of the water column (H2)**

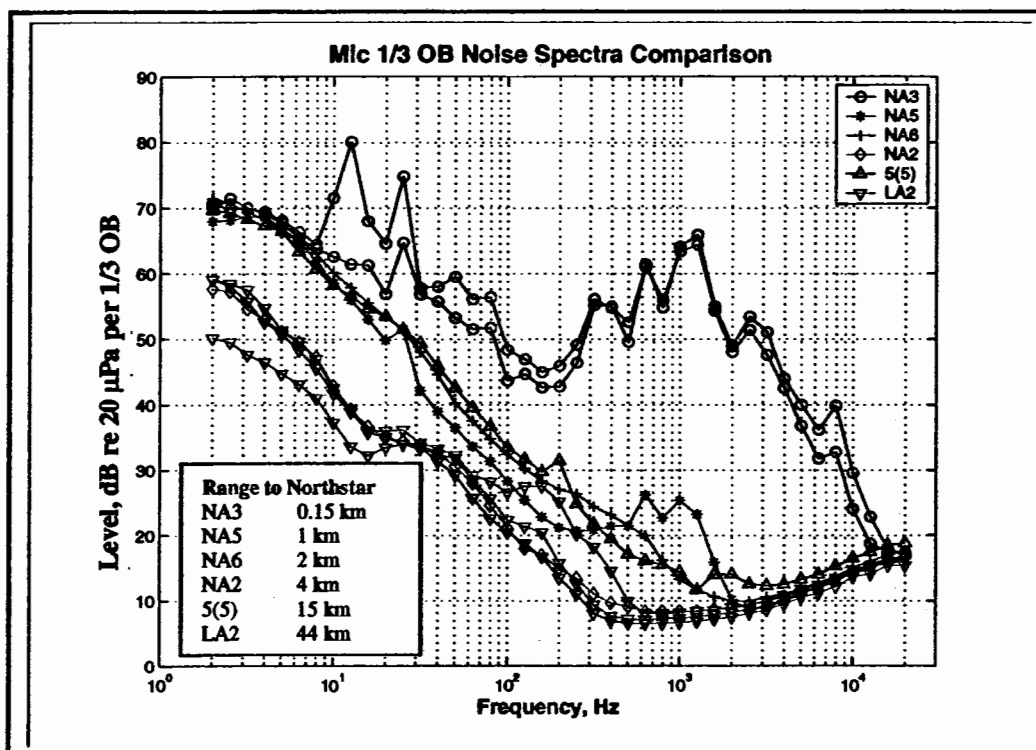
Figure 4.2-1 is a comparison of 1/3 OB measured in-air noise levels at 6 measurement sites. The vibrahammer was in operation during the data segments displayed for sites NA3, NA5, and NA6. As can be seen, at short ranges from Northstar, island noise dominates the airborne noise over almost the whole measurement band (10 Hz to about 12 kHz). But the measurements at site NA5, only 0.54 nm (1 km) from Northstar, the only apparent man-made energy above the background noise is due to the 23 Hz tonal and the .5-1.5 kHz energy. The variability in the broadband characteristics is thought to

be due to varying wind conditions. The lower noise levels measured at sites LA2 and NA2 encountered the lowest wind speeds (see Table 1-1).

Figure 4.2- 1. Comparison of 1/3 OB airborne noise spectra at multiple sites with vibrohammer in operation at least at sites NA3, NA5, and NA6.

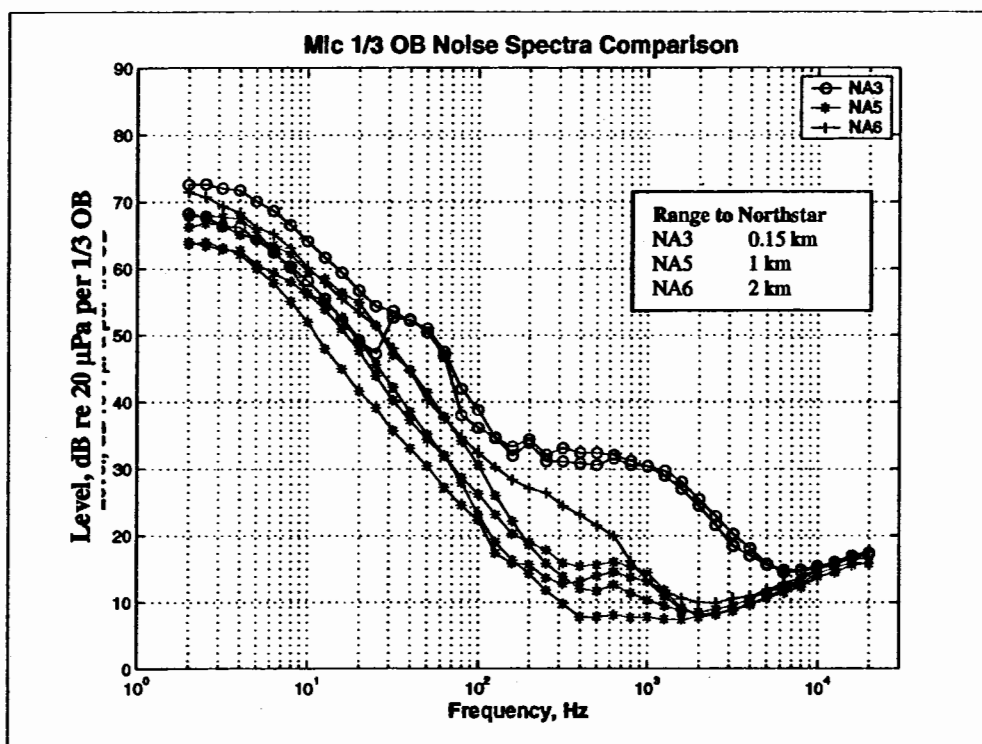
When the vibrohammer is not in operation, the airborne noise levels are considerably lower near Northstar. Figure 4.2-2 presents a comparison of measured 1/3 OB noise levels at 3 sites near Northstar. Vehicle and machinery noise drive the in-air noise levels at site NA3 but appear to have minimal impact at site NA5 located 0.54 nm (1km) from Northstar. The increased noise level at site NA6 from 100-500 Hz is unexplained.

Figure 4.2- 2. Comparison of 1/3 OB airborne noise spectra at multiple sites without vibrohammer excitation.

Airborne noise from Northstar when the vibrahammer was inactive generally produced man-made sounds only moderately above ambient levels at short range (0.08 nm or 150 m) but little appears to have been present at longer distances. See figure 4.2.2. At site NA3, measured 1/3 OB noise above ambient occurred generally across the band from 2 Hz to about 8 kHz but the majority was only 0-5 dB higher. Significant man-made noise was observed only in the 30-70 Hz (due to a limited set of narrowband tonals; figure 3.1.2-12) and 200 Hz to 4 kHz regions.

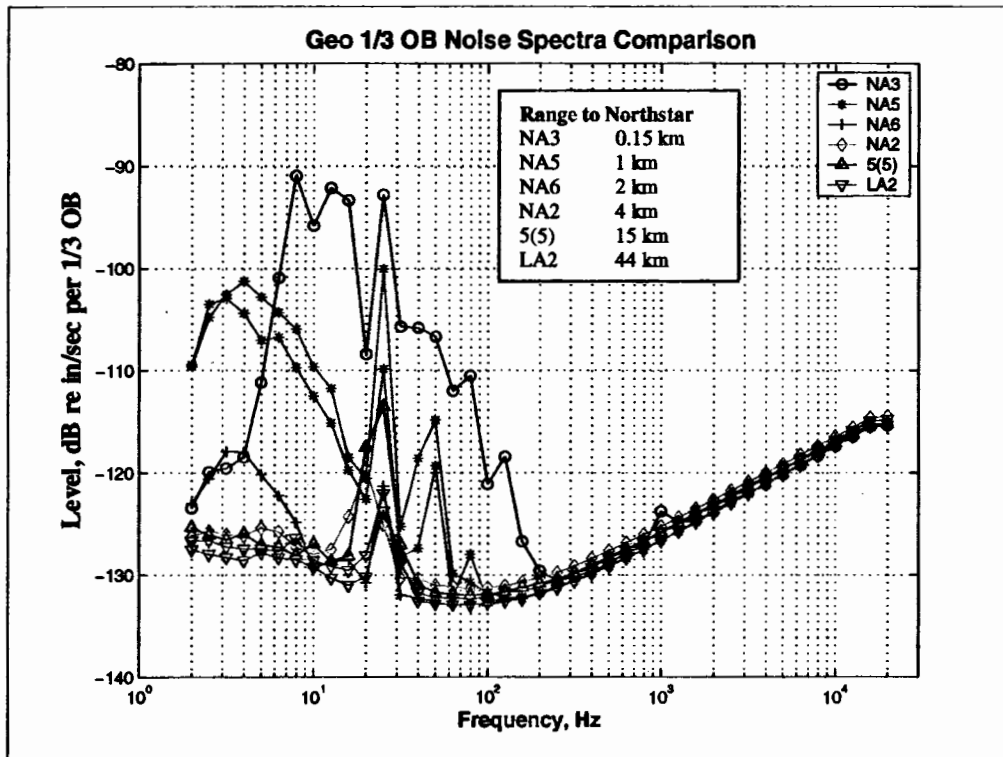
Near Northstar, man-made noise dominates the ambient noise in the frequency band below 200 Hz. Figure 4.3-1 displays measured 1/3 OB ice vibration spectra from 6 sites. The vibrahammer was in operation at sites NA3, NA5, and NA6 in this data sample. It is not known if the vibrahammer was working during the other data samples but the spectral peaks suggest that it was operating. However, the narrowband spectra at sites 5(5) and LA2 (see figures 3.1.6-6 and 3.2.1-4) show a broad peak in the 20-30 Hz band that is up to 10 Hz wide. This broadened peak is not consistent with the quite narrowband 23 Hz tonal observed at sites closer to Northstar (for example, figures 3.1.4-13 and 3.1.5-7). A mechanism that could expand a narrowband tonal to such an extent is not known. Therefore, the source of the 1/3 OB energy in the 24 Hz band cannot be defined and may possibly be due to some noise or vibration contamination caused by the measurement equipment.

**Figure 4.3- 1. Comparison of 1/3 OB ice vibration noise spectra at multiple sites with vibrahammer in operation at least at sites NA3, NA5, and NA6.**

Measured ice vibration spectral shape varies considerably from one site to another. Close in at NA3, the vibrahammer and other island noises exhibit a broad peak from 8 to 20 Hz, the 23 Hz tonal, and decaying energy from 30 Hz up to 200Hz. At a range of 0.54 nm (1 km; site NA5), island induced ice vibrations are most significant in the 2-15 Hz band probably due to machinery excitation plus two narrow spectral regions centered on 23 and about 50 Hz. The higher frequency peak is most likely due to generator vibration.

At a 1.1 nm (2 km) range (site NA6), only Northstar energy below 8 Hz and in the 23 Hz tonal was detectable above the measurement equipment noise floor. And as noted above, the source of the energy in the 1/3 OB centered at 24 Hz for sites NA6, 5(5), and LA2 is not known. When the vibrahammer was known to be in operation, the level of the 23 Hz narrowband tonal versus range is shown in figure 4.3-2. A comparison of the measured vibrahammer 23 Hz tonal level versus range collected underwater in figure 4.1-1 with the range dependence of the ice vibration levels depicted in figure 4.3-2 shows that the fall-off is comparable. This indicates that the ice is being driven by water-borne energy rather than direct transmission from the island into the ice.

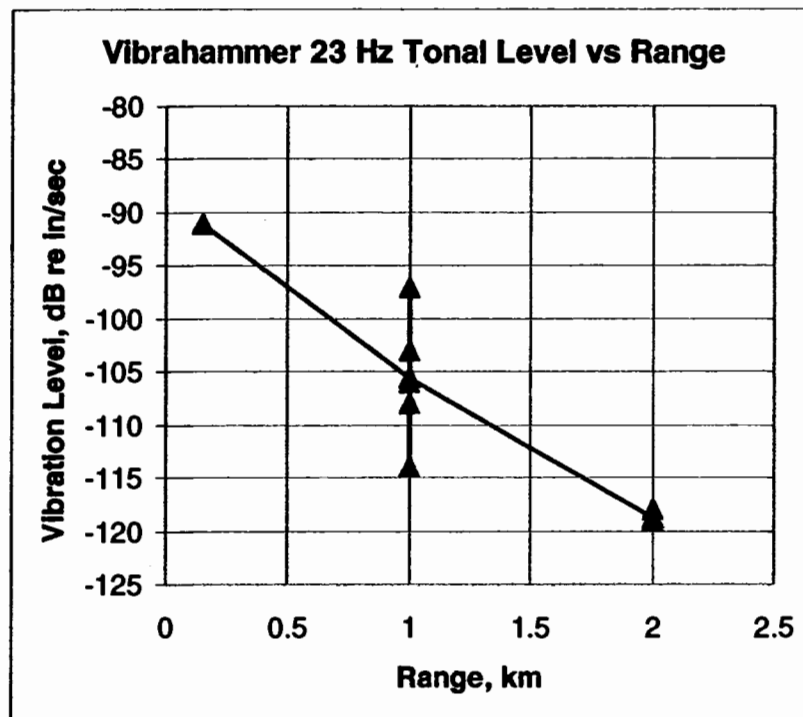
Figure 4.3- 2. Vibrahammer 23 Hz tonal received ice vibration spectrum level as a function of range.

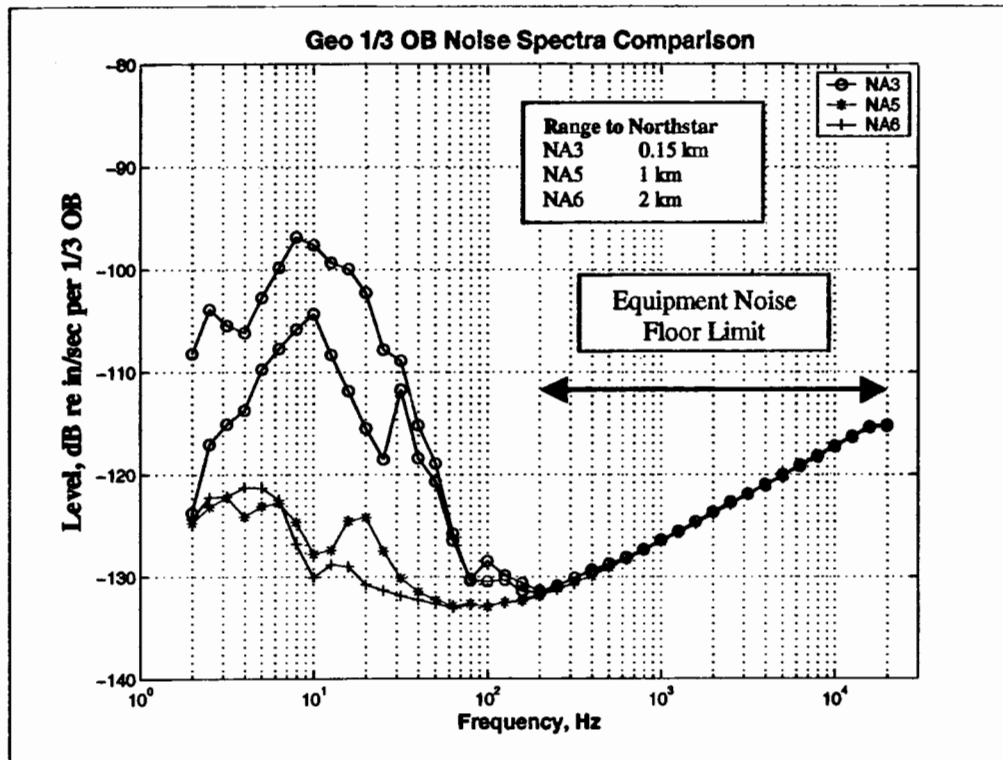
Figure 4.3-3 presents 1/3 OB ice vibration levels for three sites while the vibrahammer was not in operation. Trucking and machinery are seen to be the dominant source of ice vibrations below about 150 Hz. The ice vibration levels fall off significantly at a 0.54 nm

(1 km) range (NA5) and except for the man-induced vibrations below 10 Hz, have disappeared at a range of 1.1 km (2 km) (site NA6).

**Figure 4.3- 3. Comparison of 1/3 OB ice vibration noise spectra at multiple sites without vibrohammer excitation.**
